RESOLUTION OF THE
NAVAJO NATION COUNCIL

RELATING TO NAABIK'ÍYÁTI' COMMITTEE AND NAVAJO NATION COUNCIL;
ACCEPTING THE CONVEYANCE OF FEDERALLY OWNED BUILDINGS AND/OR
IMPROVEMENTS AT THE OLD THOREAU BOARDING SCHOOL FACILITIES IN
THOREAU, NEW MEXICO

THOREAU/ DLO'AY'AZHI COMMUNITY SCHOOL DEMOLITION/TRANSFER

PHASE II ENVIRONMENTAL SITE ASSESSMENT

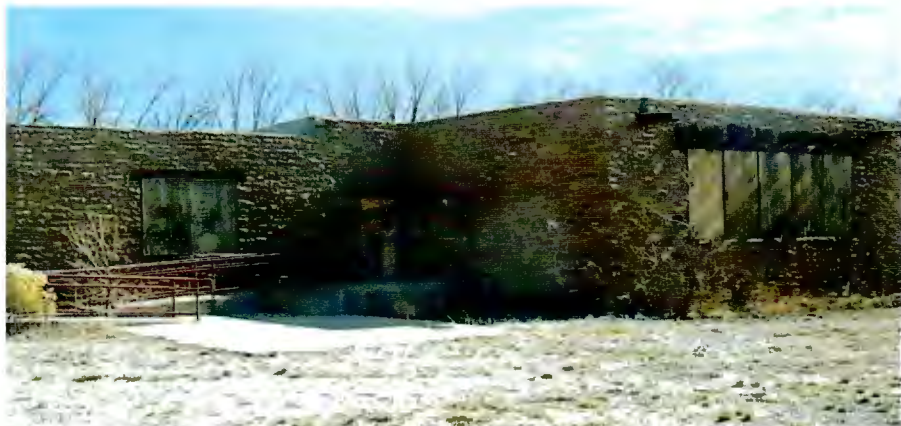
Photograph 1.
Building No. 901
built in 1935. Stone masonry with protruding vigas and flat roof is typical of older buildings on the campus.

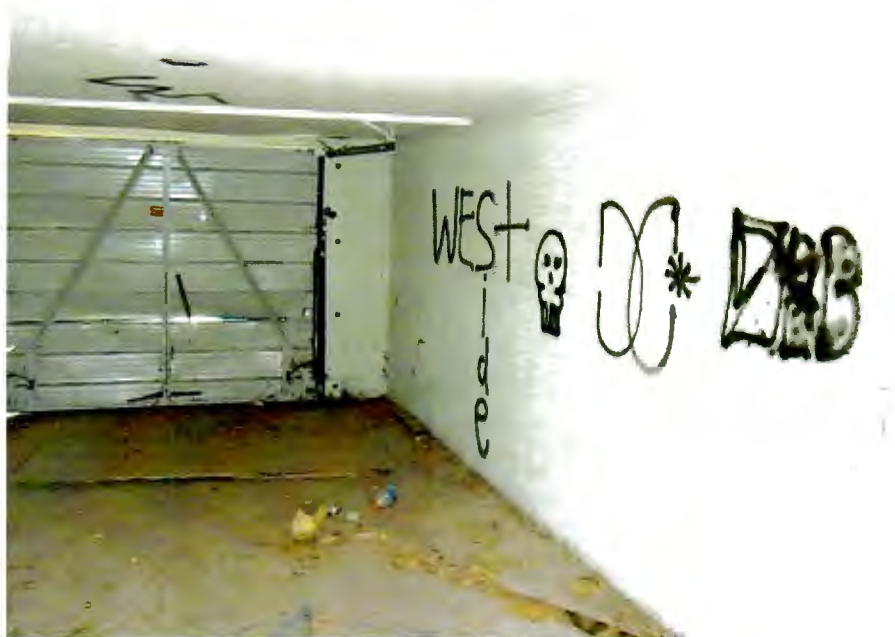
Photograph 2. Shelters for gang activity and other undesirable behavior would be removed by the proposed project. Here is the vandalized interior of one of the garages at the site.

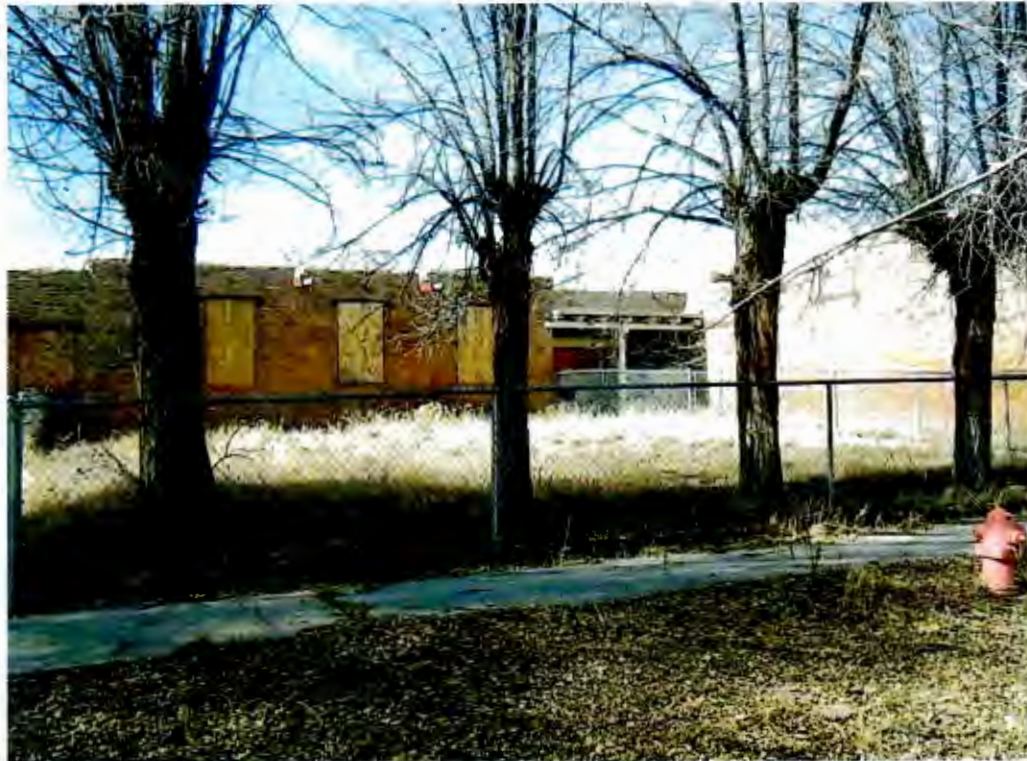
Photograph 2. Building no. 901, trees are Chinese elm.

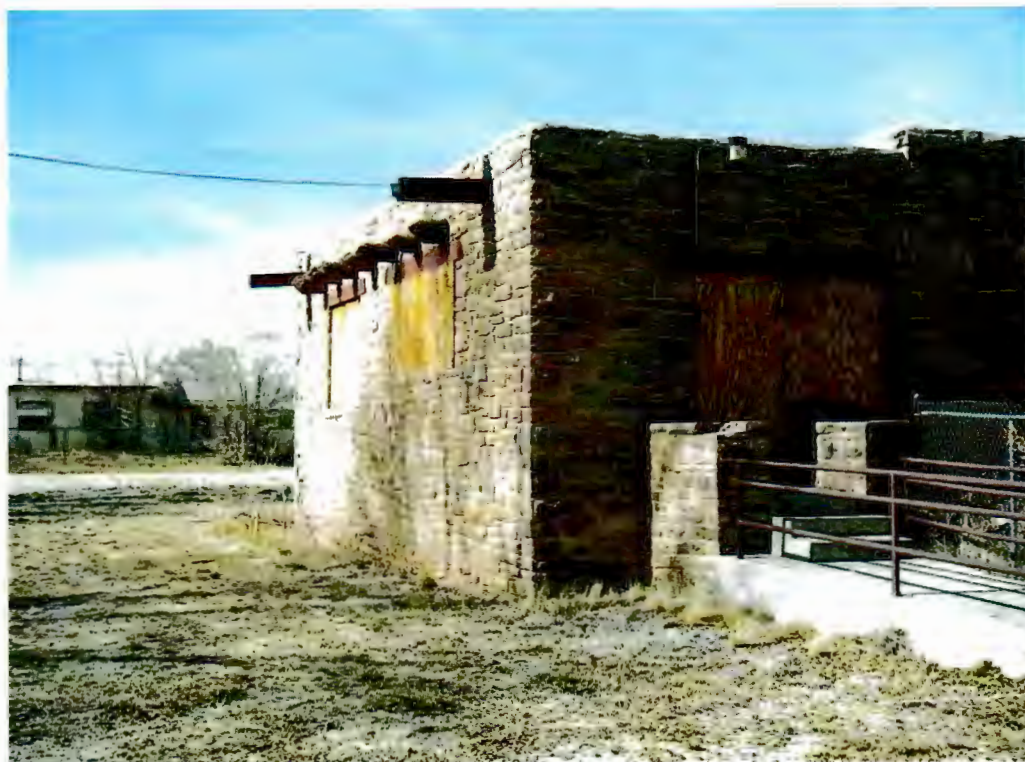
Photograph 3. Building 901 showing stone masonry and vigas.

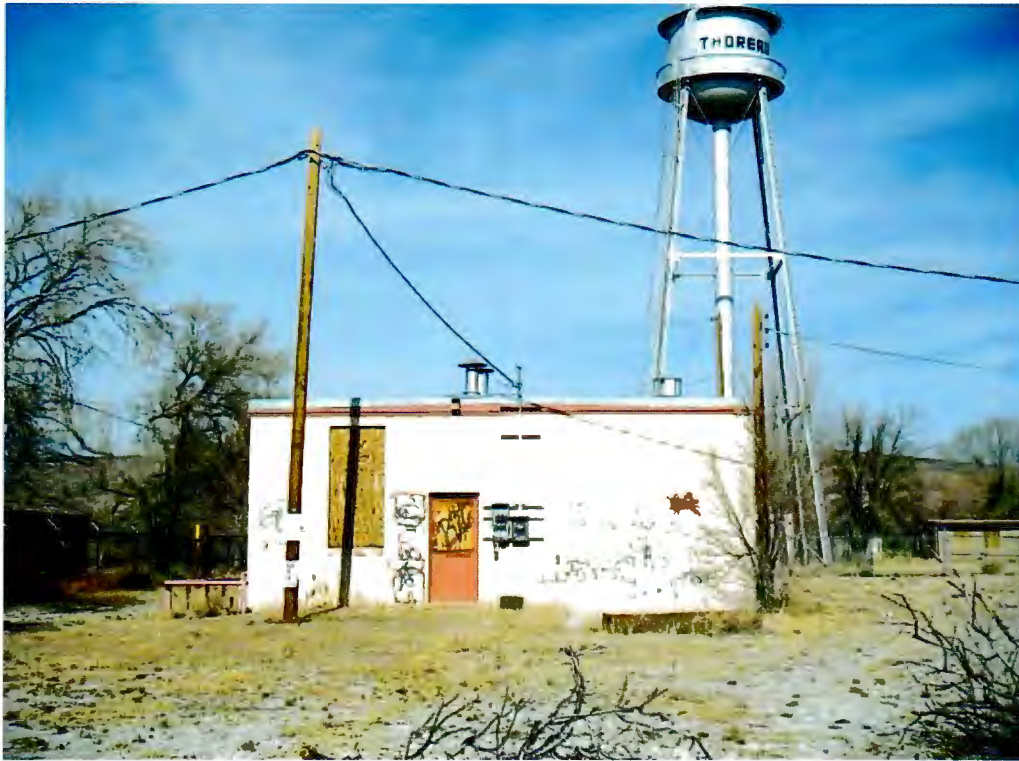
Photograph 4. Building no. 916 Utility Plant. Vandals have removed electrical components and left graffiti throughout the school.

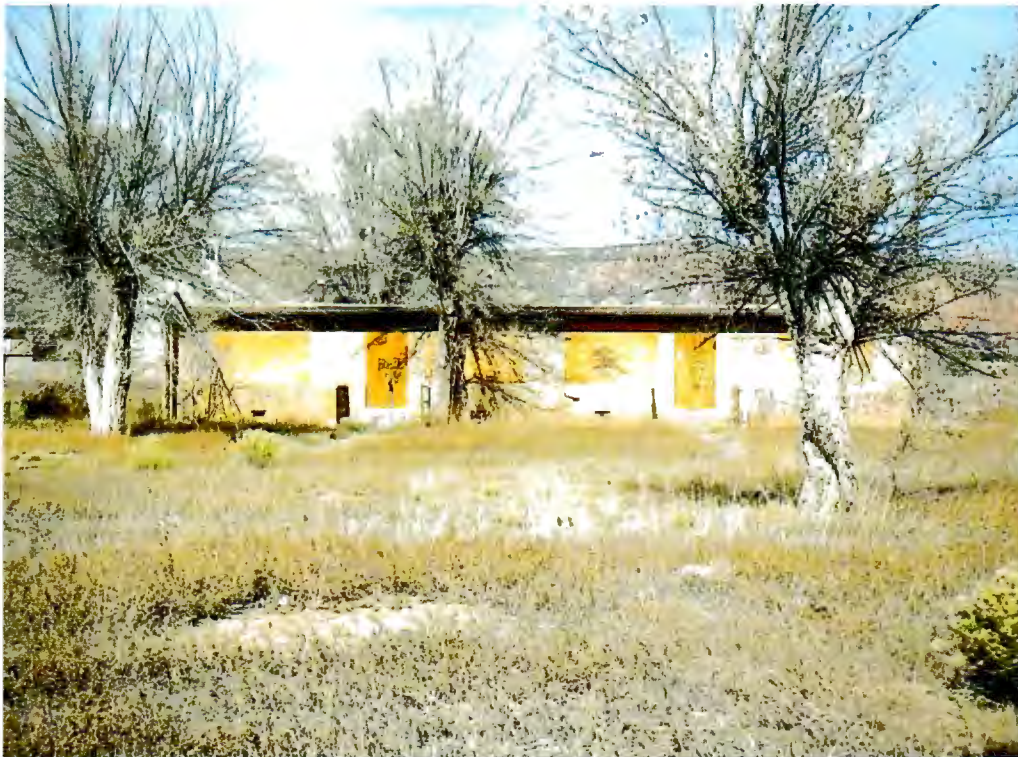
Photograph 5. Building no. 907 duplex housing, similar to building nos. 909 and 910.

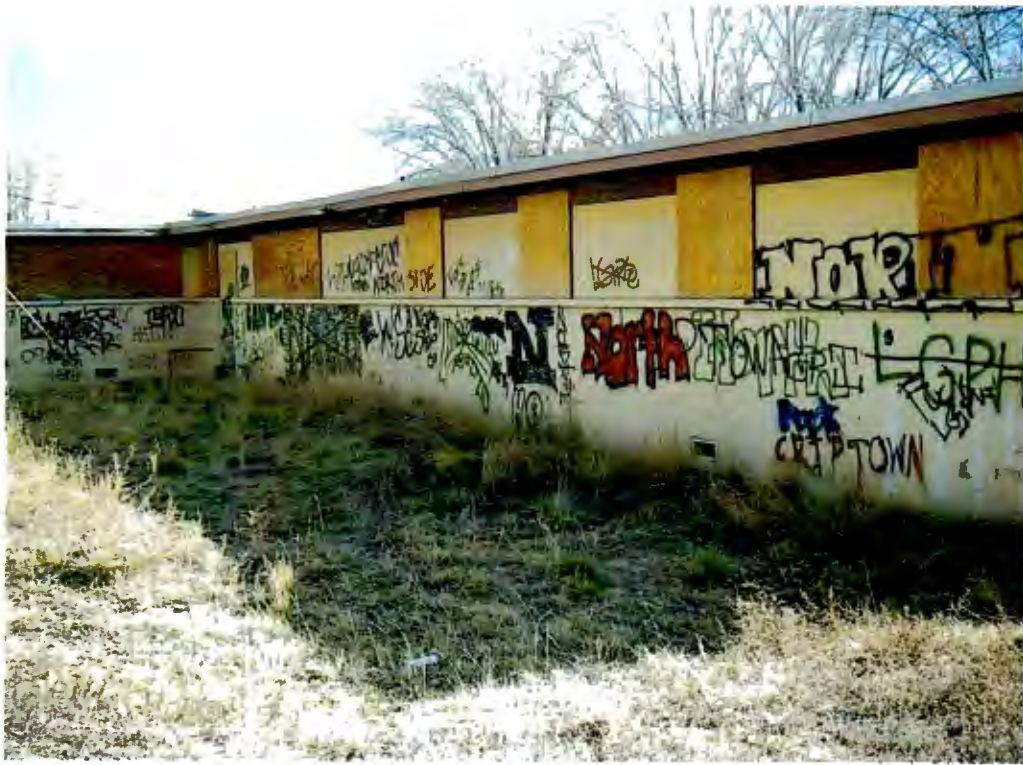
Photograph 6. Building no. 915, extensive graffiti and vandalism.

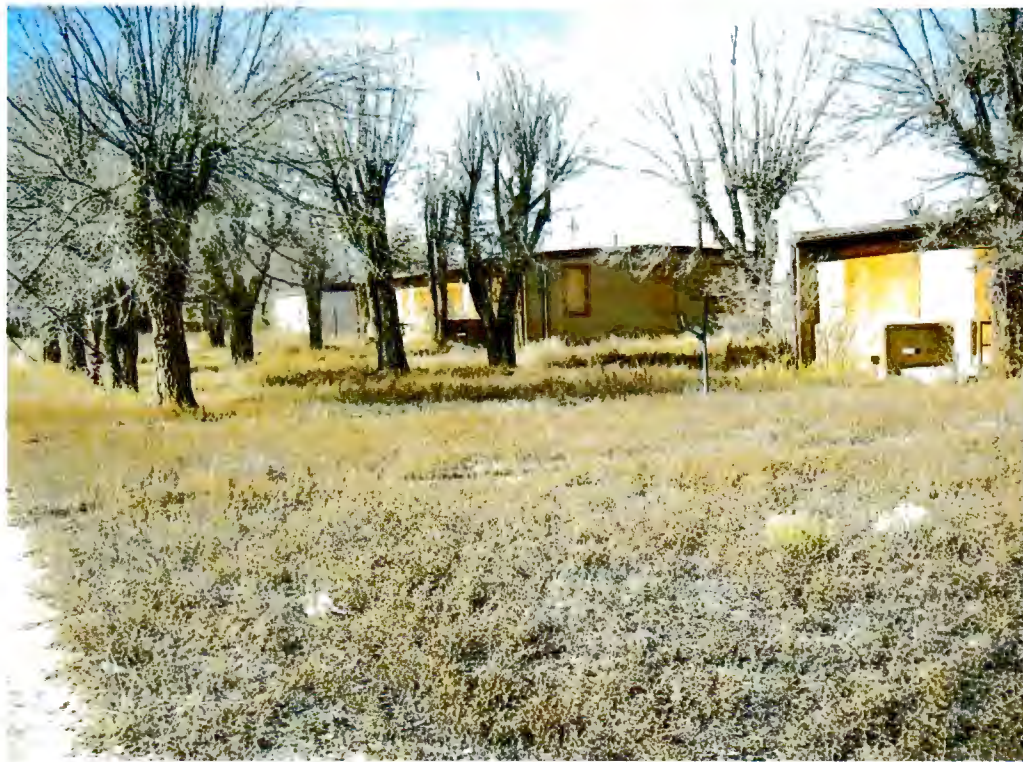
Photograph 7. Buildings no. 909 and 910, duplex apartments.

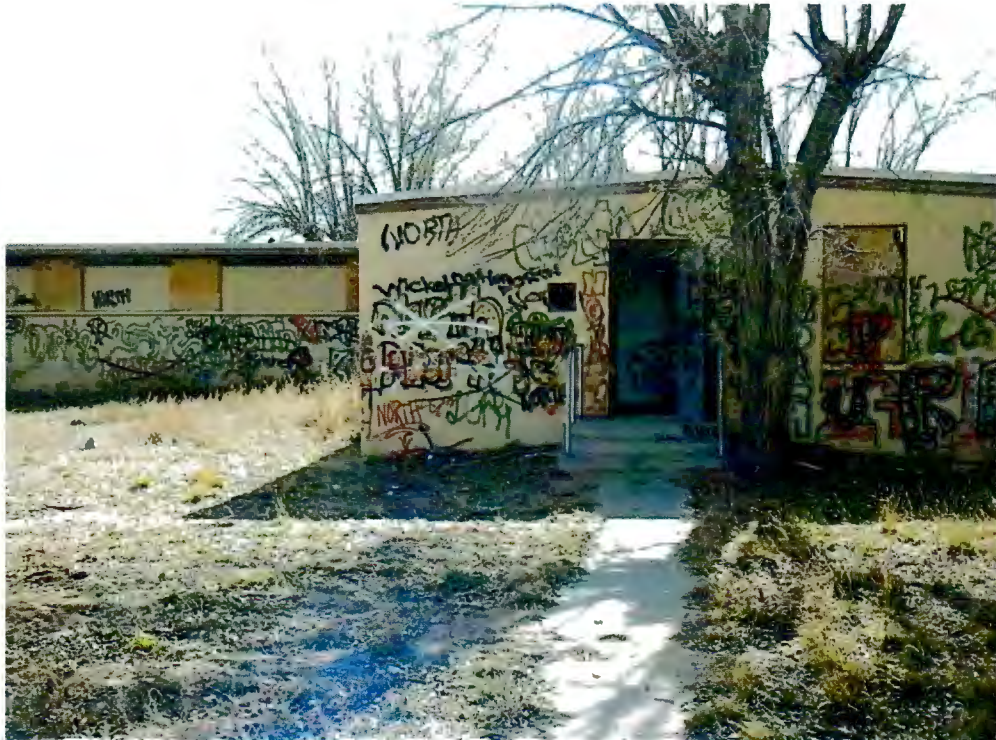
Photograph 8. Building no. 914 with vandalized exterior and interior. Several buildings on the campus have been broken into.

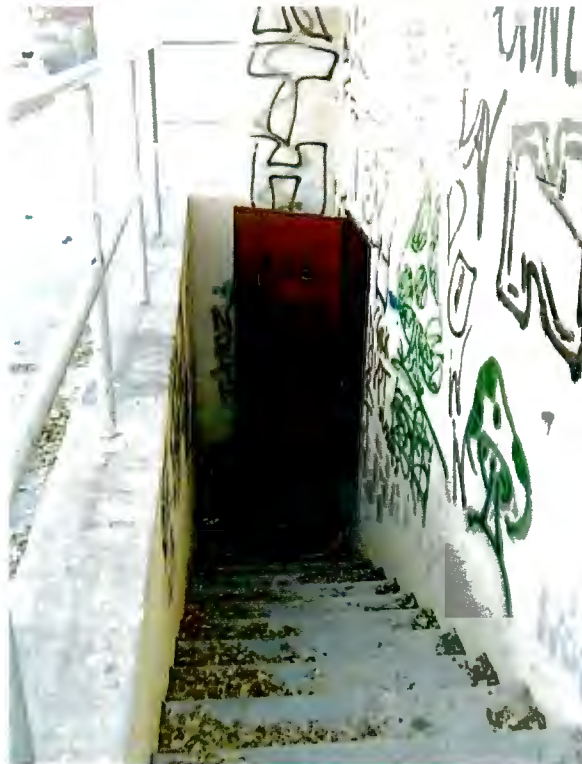
Photograph 9. Building no. 914 basement door forced open. A water pump and plumbing is in the basement.

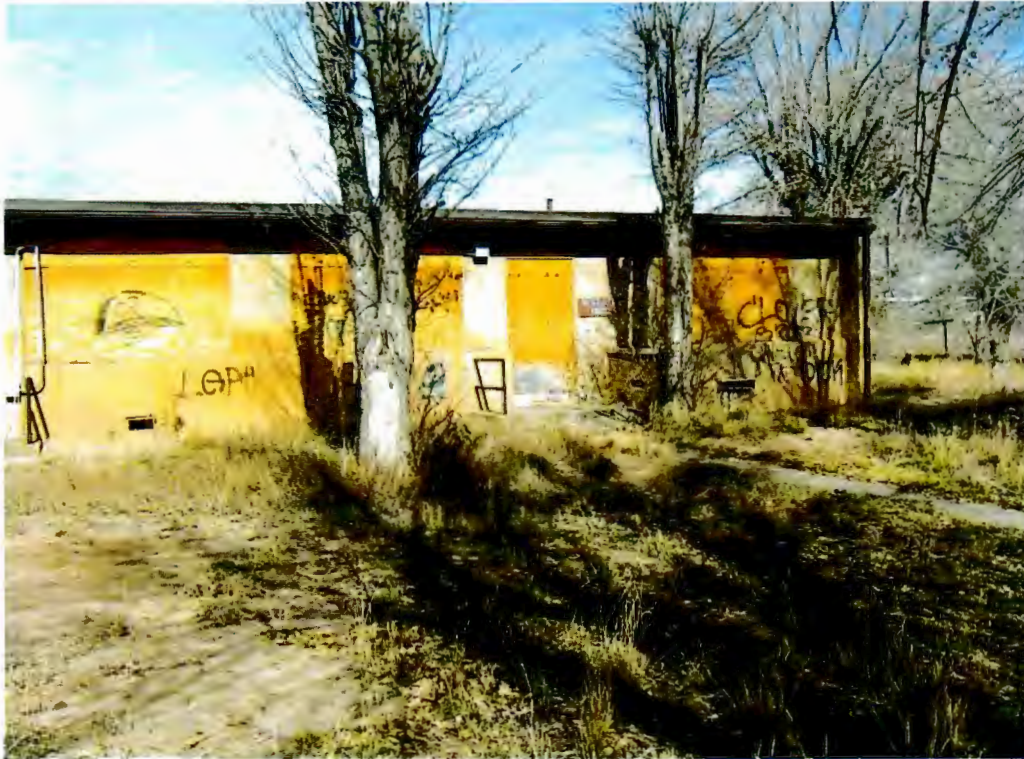
Photograph 9. Building no. 912 Resource Room.

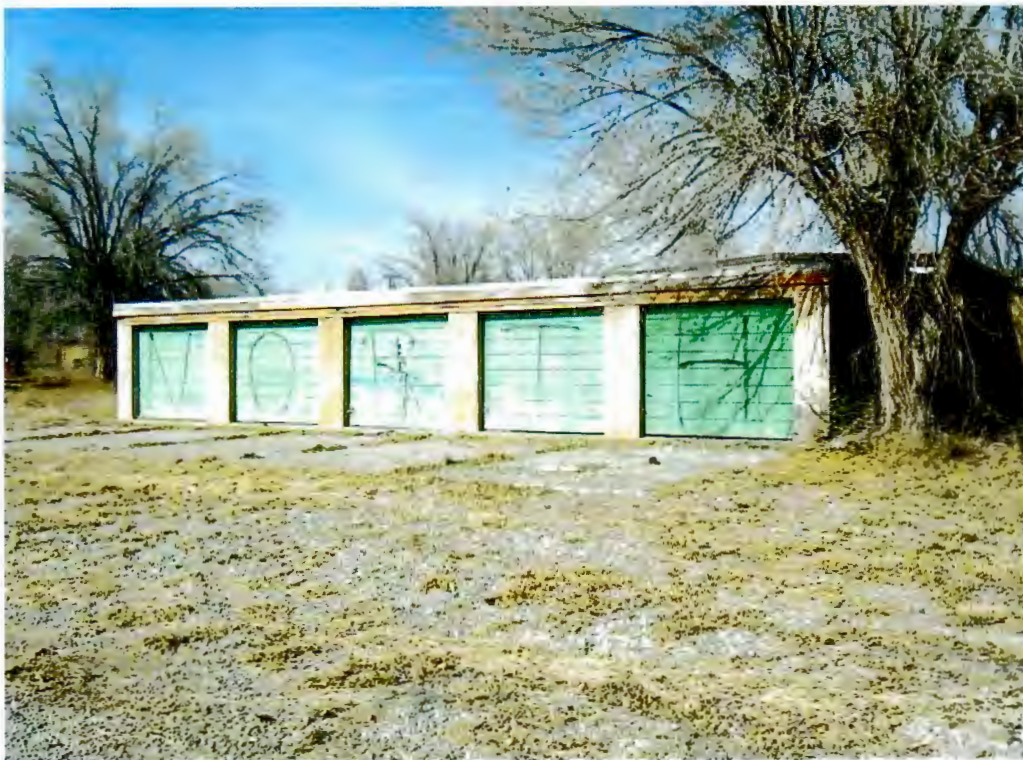
Photograph 10. Building no. 913, garage bays.

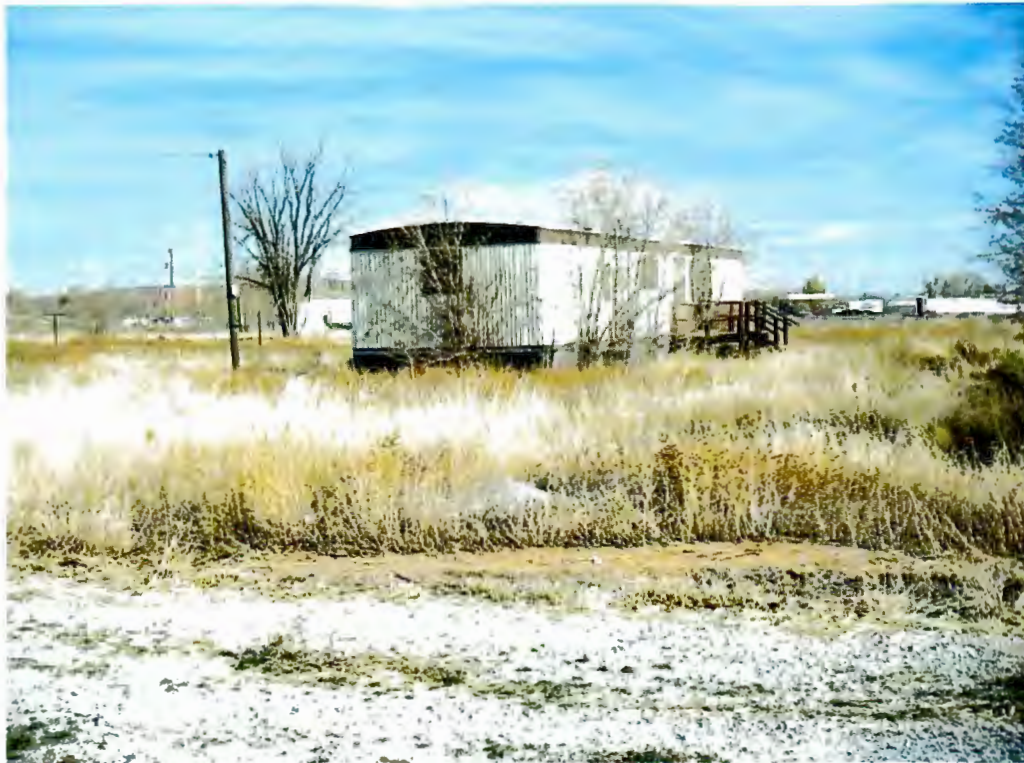
Photograph 11. Building no. 154980, a mobile home.

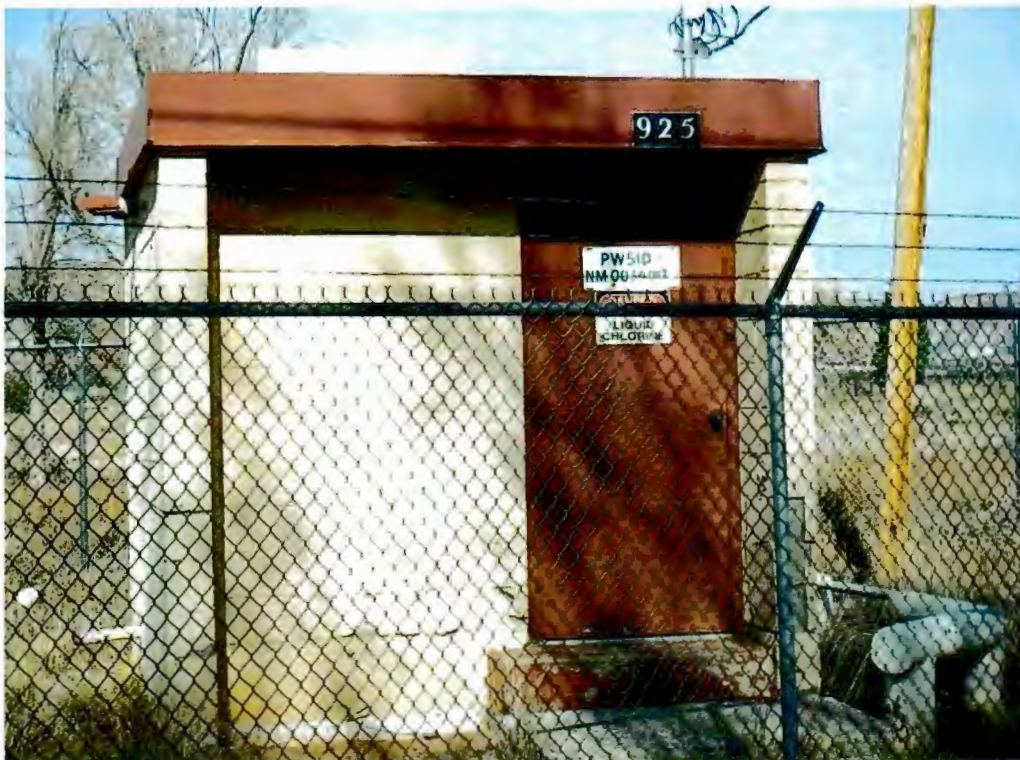
Photograph 12. Building no. 925, a water treatment building. The fence gate was damaged and open.

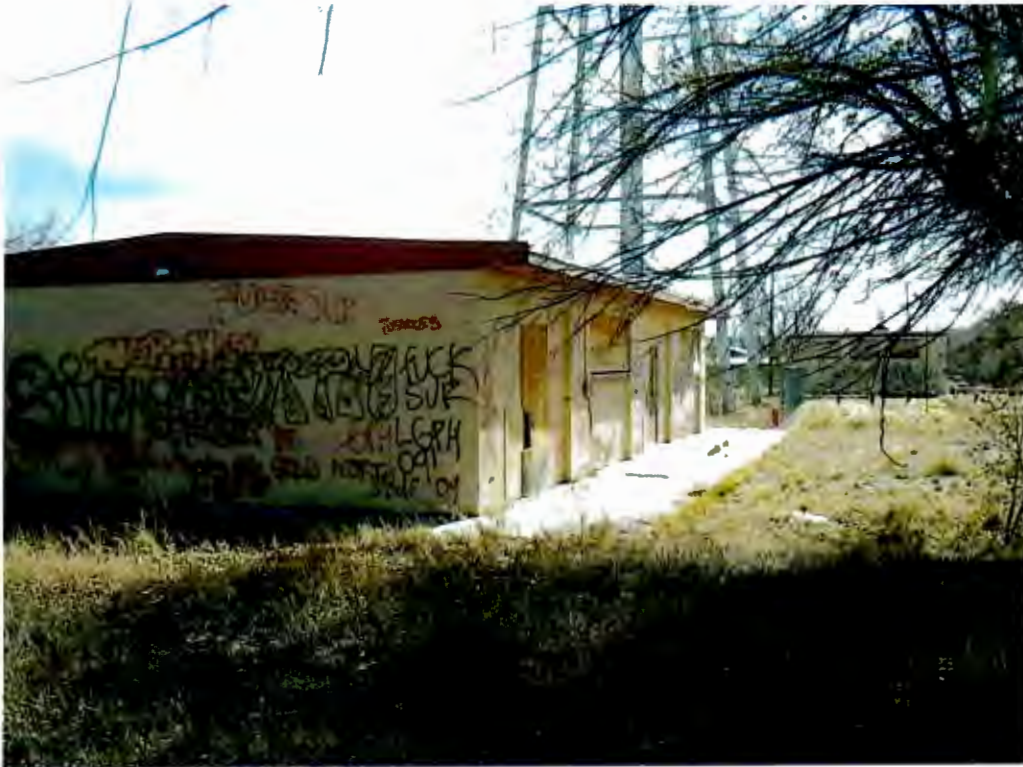
Photograph 13. Building no. 904, appears to be vocational education building.

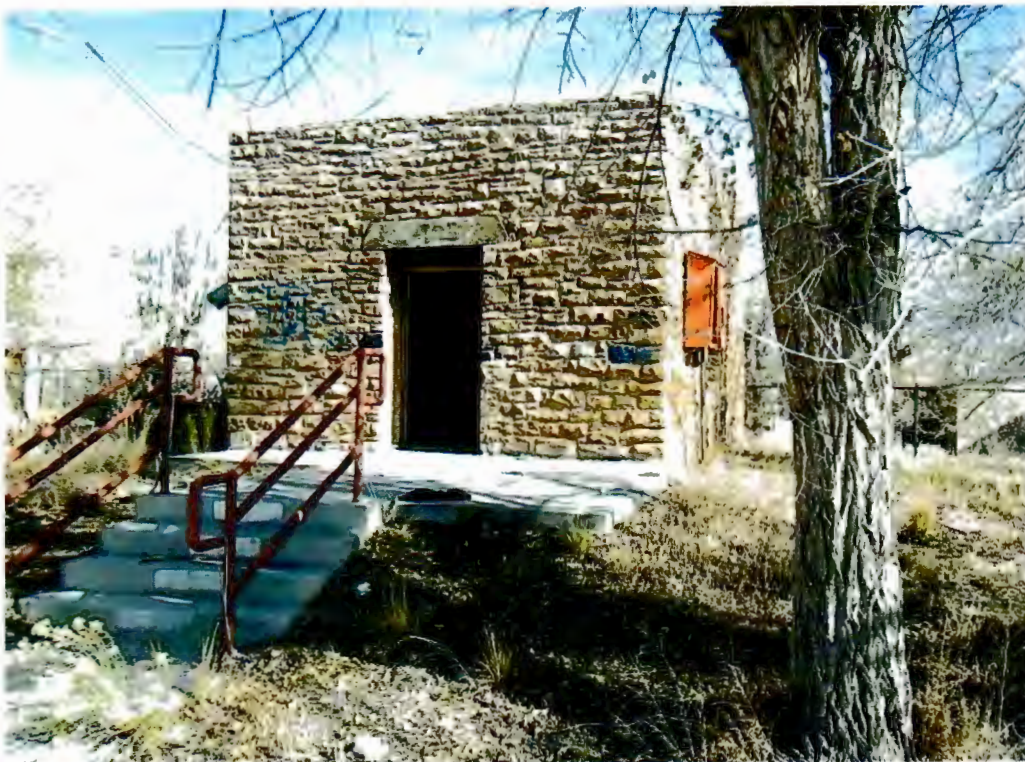
Photograph 14. Building no. 903 an office, built in 1935.

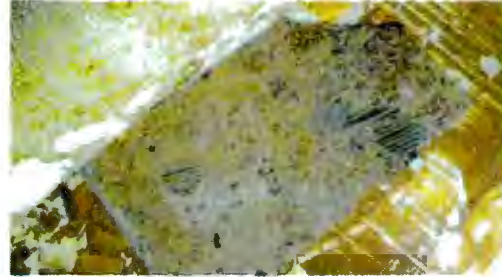
Library floor tile, black mastic is 4% Chrysotile.

AES recommends that the ACM be properly characterized and abated prior to remodeling or demolition activities that might disturb the material. There may be fluorescent light fixtures with ballasts that contain PCBs, and there are three poles on the north side of the site along the east/west dirt road that may have PCB containing transformers. A 55 gallon drum of Liquichlor exists in the well house on the northwest portion of the property.

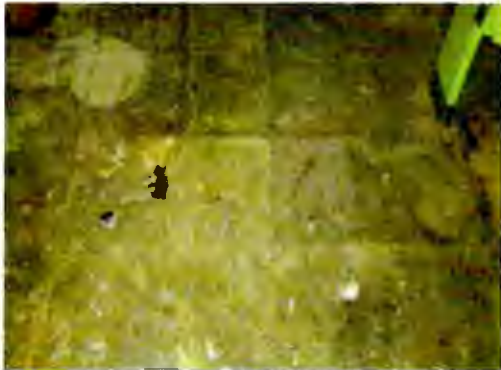
North restroom floor tiles. 10% Chrysotile

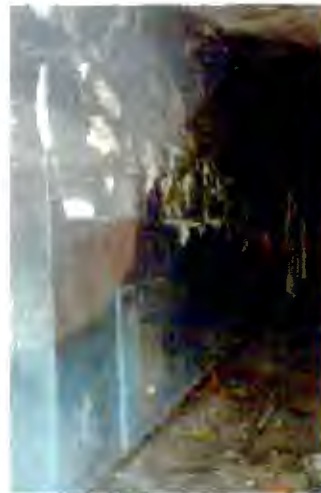
Hall stucco walls.

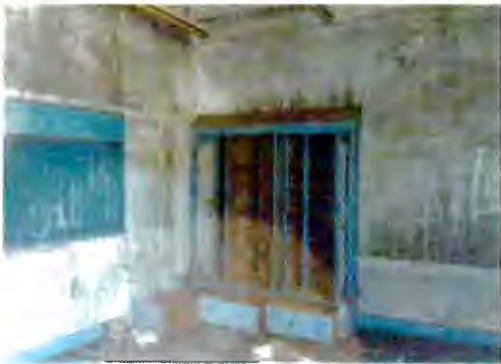
Classroom stucco walls.

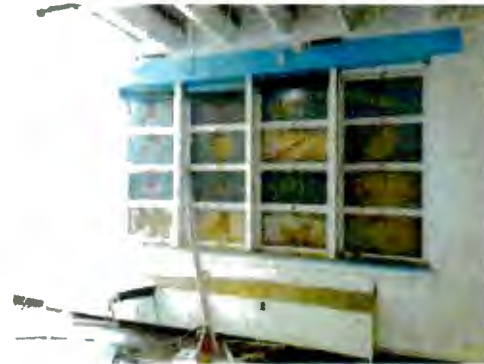
Windows with gray window glaze.

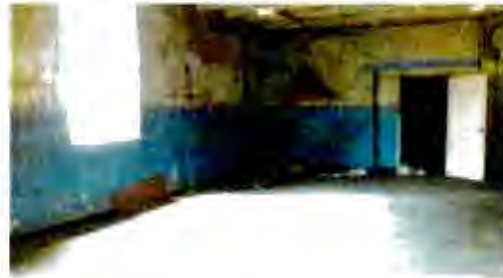
Dining room stucco walls.

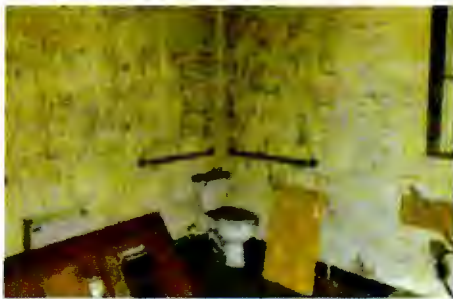
Restroom by kitchen.

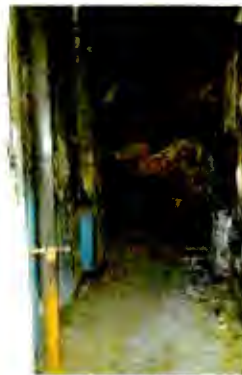
Fire damage to hall and North end of building.

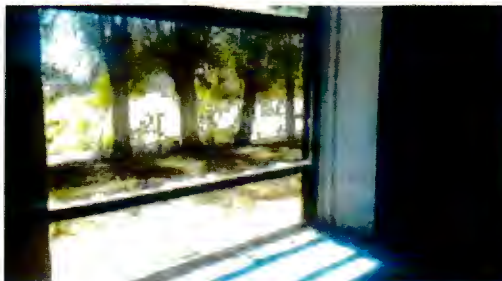
Window glaze.

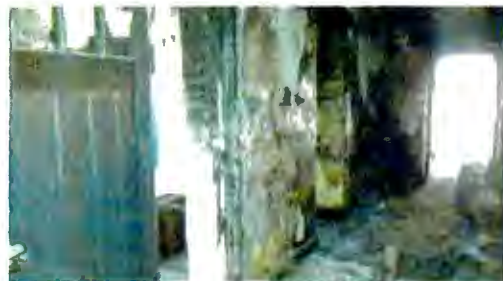
South end hall wall.

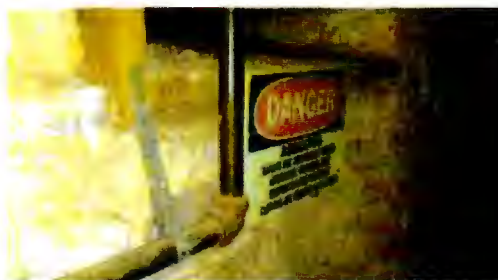
Basement: Asbestos Danger signage.

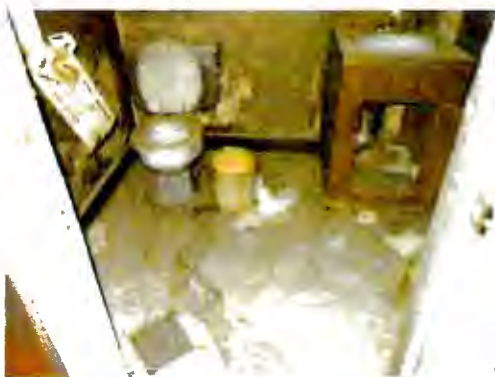
Restroom by Room D.

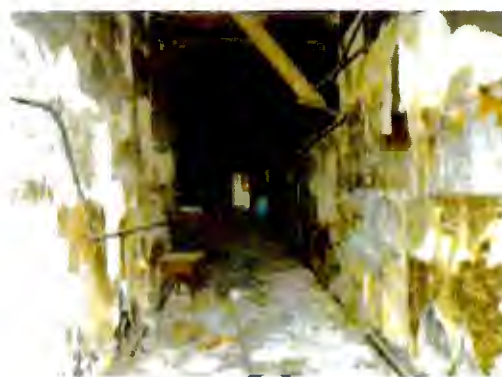
Fire damage to South end hall stucco wall.
