RESOLUTION OF THE
NAVAJO NATION COUNCIL

RELATING TO RESOURCES AND DEVELOPMENT COMMITTEE, BUDGET AND FINANCE COMMITTEE, NAABIK'ÍYÁTI' COMMITTEE AND THE NAVAJO NATION COUNCIL; APPROVING SUPPLEMENTAL FUNDING FROM THE UNRESERVED, UNDESIGNATED FUND BALANCE IN THE AMOUNT OF \$500,000.00 FOR TEECNOSPOS CHAPTER FACILITY RENOVATION; WAIVING 12 N.N.C. § 820(I) AND 860(C) RELATING TO THE CAPITAL IMPROVEMENT PROCESS

G. The Teecnospos Chapter Facility Renovation is not included in the Title 12 Capital Improvement Plan.

- I. The Teecnospos Chapter President declared a State of Emergency effective 8 a.m. on May 22, 2015 due to the effects of rain damage to the chapter house roof. The State of Emergency states that the Navajo Nation Occupational Safety and Health Office recommended the closure of the facility. The Teecnospos Chapter is temporarily located at the Navajo Nation Veteran's Office building which is not suited for the purposes of the Chapter. The Teecnospos Chapter resolution and the Chapter President's State of Emergency Declaration are attached as Exhibit C.

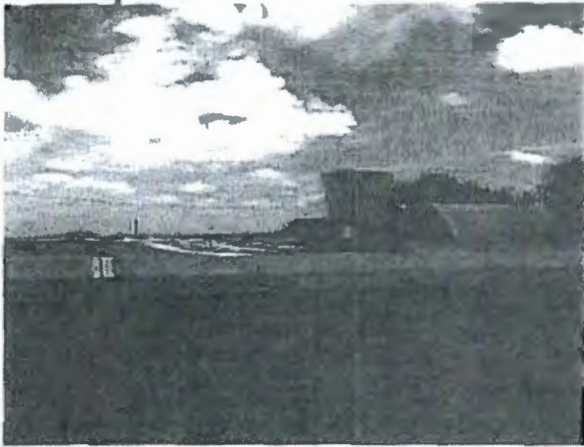
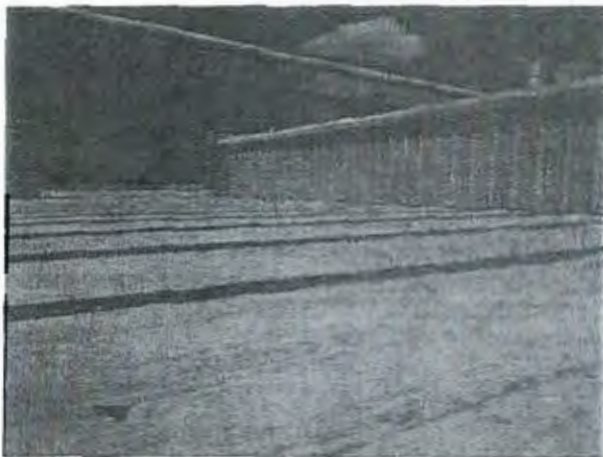
- The overlap of the metal panels are not installed correctly. Panels are butting up to one another and roof tar was applied to prevent water from entering. The correct installation should have an overlap of a minimum of 3" or per manufacturing's recommendation. **See attached photo.**

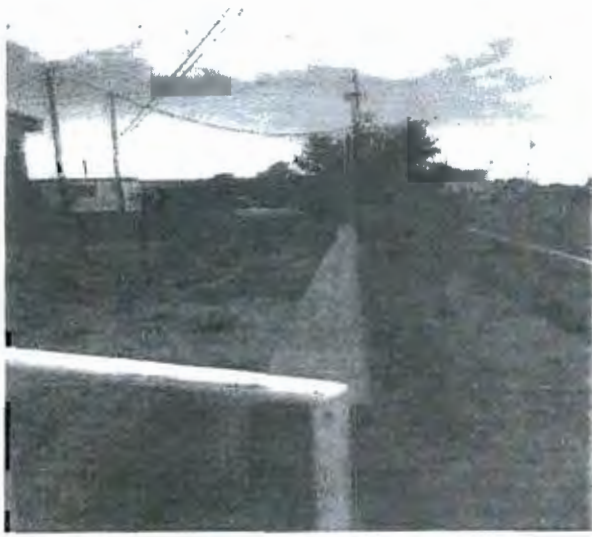
- The retaining wall located on the north side of the building needs to be address. The wall is tilting outwards towards the parking area and could endanger the pedestrian and/or surrounding community. **See Attached Photo.**

- Minor site preparation of ADA parking areas.
- Replace and install walls with glass panel and door
- Upgrade public/employee restrooms.
- Demolition and install new retaining walls at north side of the building

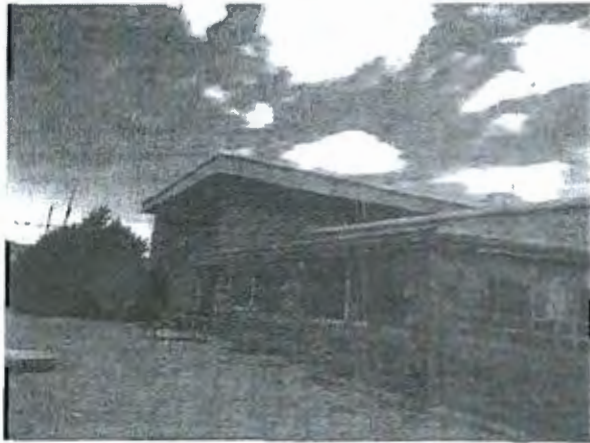
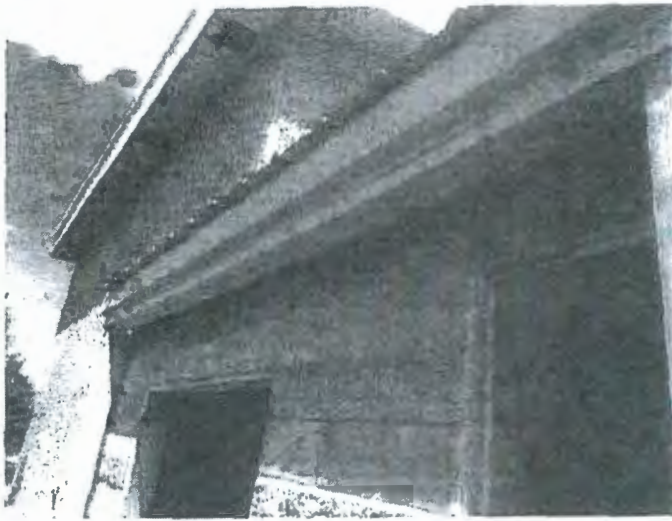
- We, NNDES recommend the removal the of the south exterior break area due to the cracks in the mortar joints and the extend deflection of the load bearing beams. Also the door height are not to the correct heights and do not meet the current codes. And there are no correct steel lintels at doors and openings.

- Demolition of the south exterior/outdoor break area
- Inspect/replace HVAC system which includes

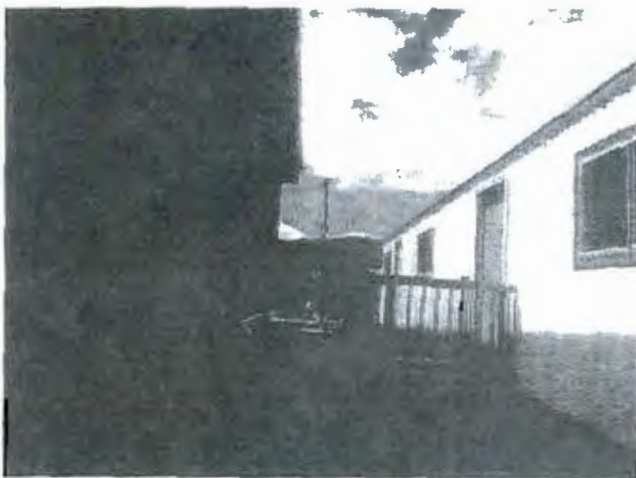
Building electrical had is within its capacity and is now sufficient to the additional load draw for new appliances, HVAC equipment, and additional offices. The building electrical outlets and lighting fixtures need to be replace and an electrical engineer will need to review and provide new electrical system plans for the building. All existing exposed electrical wires need to be removed. On the west end of the building, the three (3) phase line, right of way, is within the building perimeter.

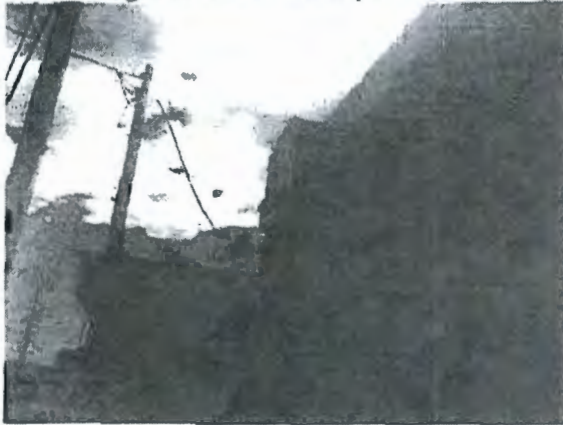
Building is currently heated and cooled by an outdated HVAC system and Swamp cooler unit, in the winter/summer months heat is a problem. Currently the existing system sits in the roof and side of the building with condensation problems and majority of the duct system are not insulated.

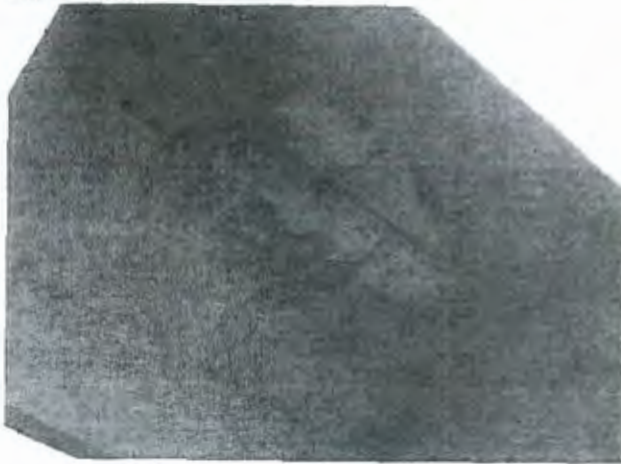
An investigation was conducted for mold/bacteria testing within the building ceiling where the water penetrated the roof area as we were told by the Chapter manager. The firm, ECI-EnviroScience Consulting, Inc., conducted the Mold and bacteria testing and the contact person is Ms. Angie White. The containments will need to be abated properly and disposed of by the licensed remediation team and/or firm.

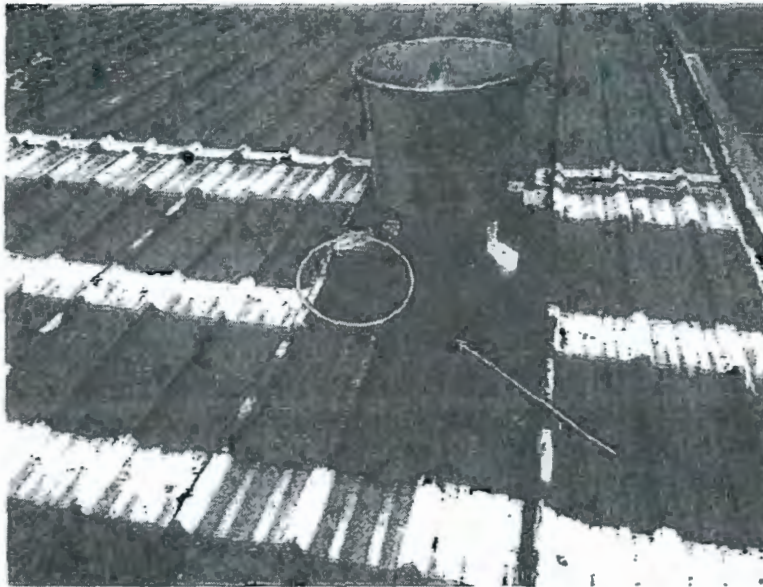
Photo of vent above the kitchen area note the dirt built up which is a sign of standing water that penetrated the seams and into interior ceiling.

Base on the assessment, it our recommendation that to stop any moisture intrusion we must repair the roof as

soon as possible. Once this is accomplished then the interior moisture intrusion and damages can be remediated and rehabilitated. Therefore, it is recommended that mold remediation be conducted within the parameters of IIRCRC S520 (Institute of Inspection, Cleaning and Restoration Certification standard) methodology. This would assist in re-establishing a safe work and public service environment.

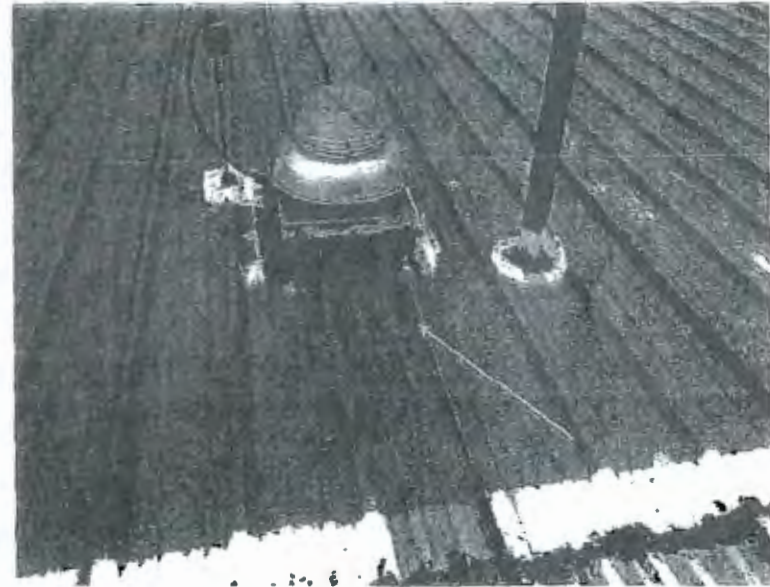
Photo of standing water on roof top and damaging the seam.

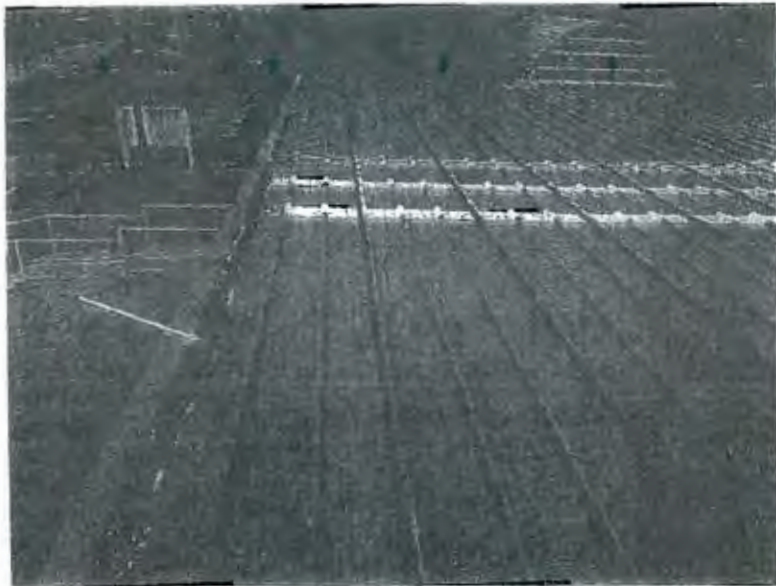
Different colors of sealants applied to prevent moisture intrusion at the seams. Unknown how thick the layer of roof material is underneath the pro-metal panels.

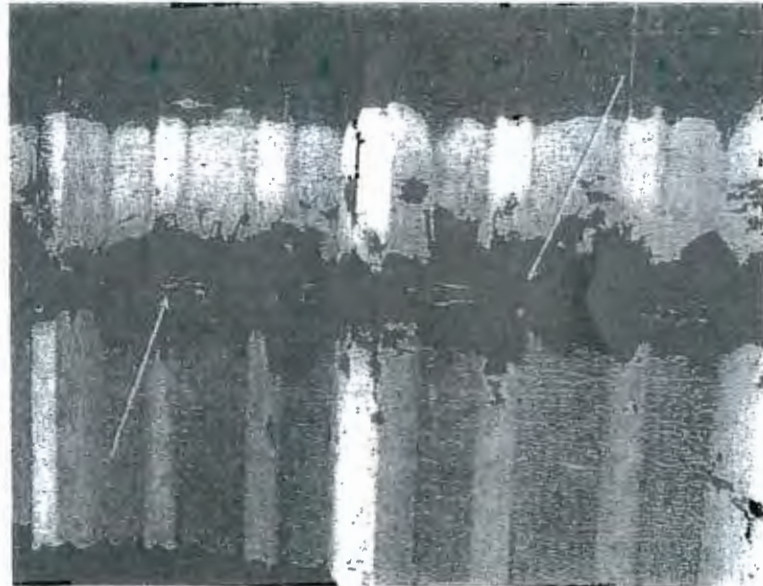
Close of weather and damage sealants at seams of pro-metal panels. It is suspected that the screws have buckle from the expansion and contraction of materials.

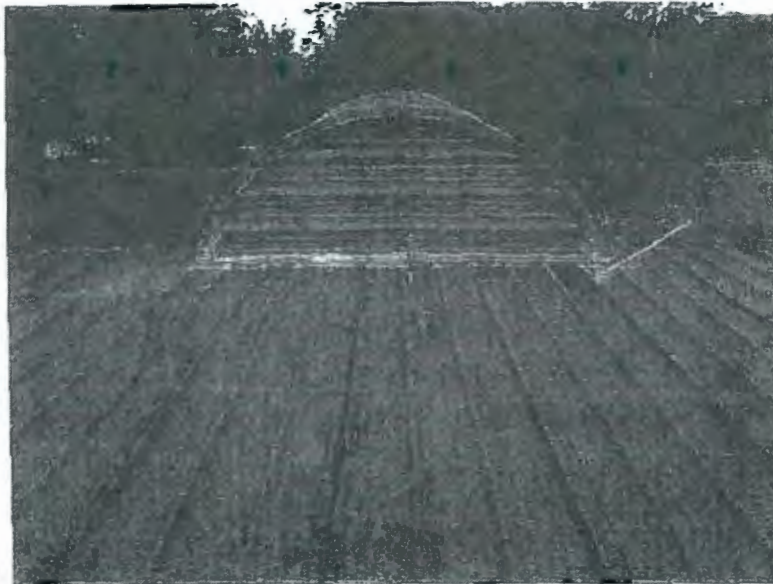
The "dome" above the front entrance, note the visible sign of dirt and moisture at the edge of dome. Should have some slope to have water run off to drainage. Presently water drains in wall cavity of men's restroom.

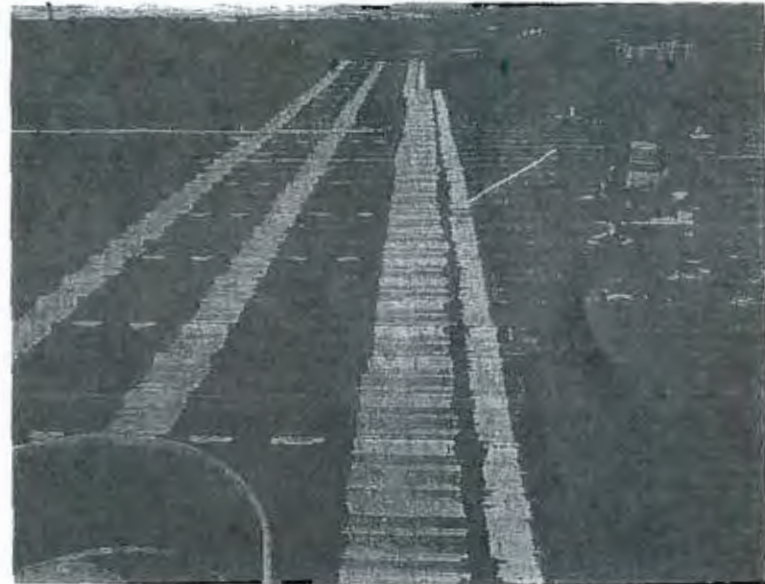
Photo of roof top showing pro-metal panels seams and sealants application to prevent moisture intrusion.

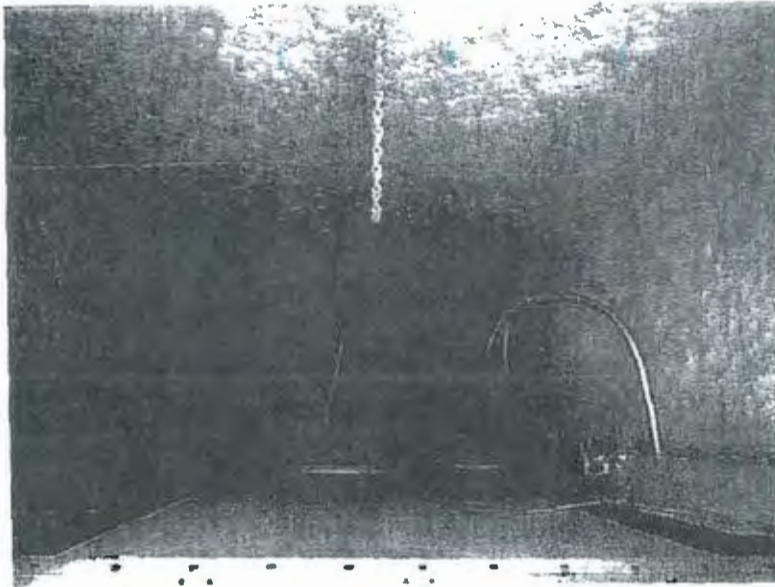
Other material we can encounter above the ceiling are network cables, light fixtures, vents and non-bearing load walls.

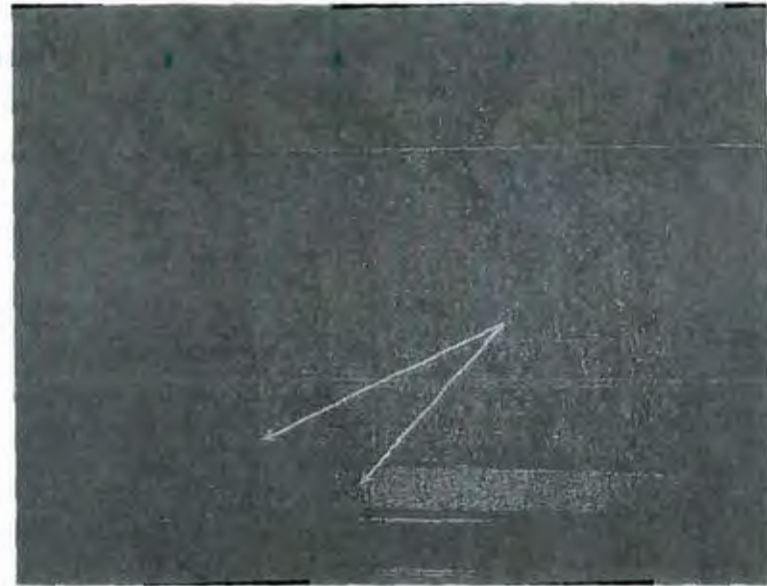
Photo shows concrete roof expansion and non-bearing load wall that are moisture damage. Moisture travel underneath the fireproofing and onto the wood wall saturating the materials.
