RESOLUTION OF THE
NAABIK'ÍYÁTI' COMMITTEE OF THE
NAVAJO NATION COUNCIL

RELATING TO HEALTH, EDUCATION AND HUMAN SERVICES AND
NAABIK'ÍYÁTI'; URGING THE U.S. DEPARTMENT OF THE INTERIOR TO
RECONSIDER A SCHOOL CONSTRUCTION APPLICATION SUBMITTED BY SHONTO
PREPARATORY SCHOOL

SCHOOL
REPLACEMENT
❖
APPLICATION
FY 2015

1. OVERVIEW OF SCHOOL / RESIDENTIAL FACILITY

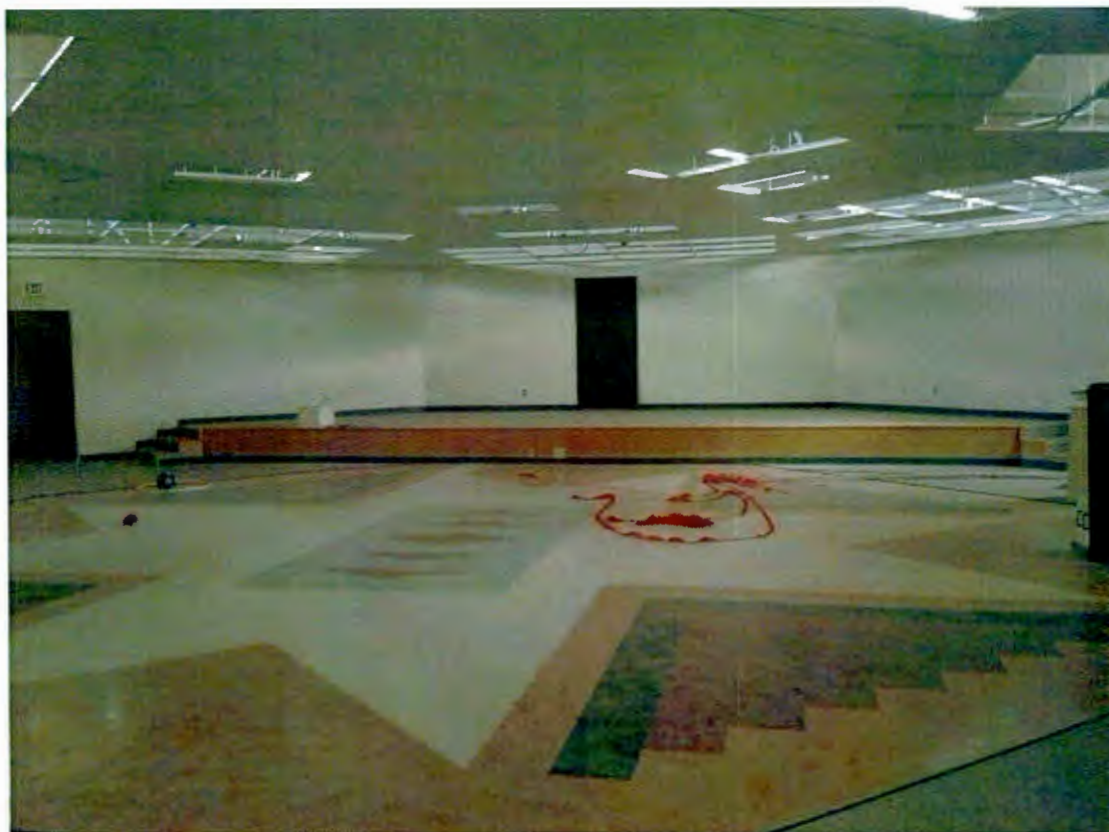
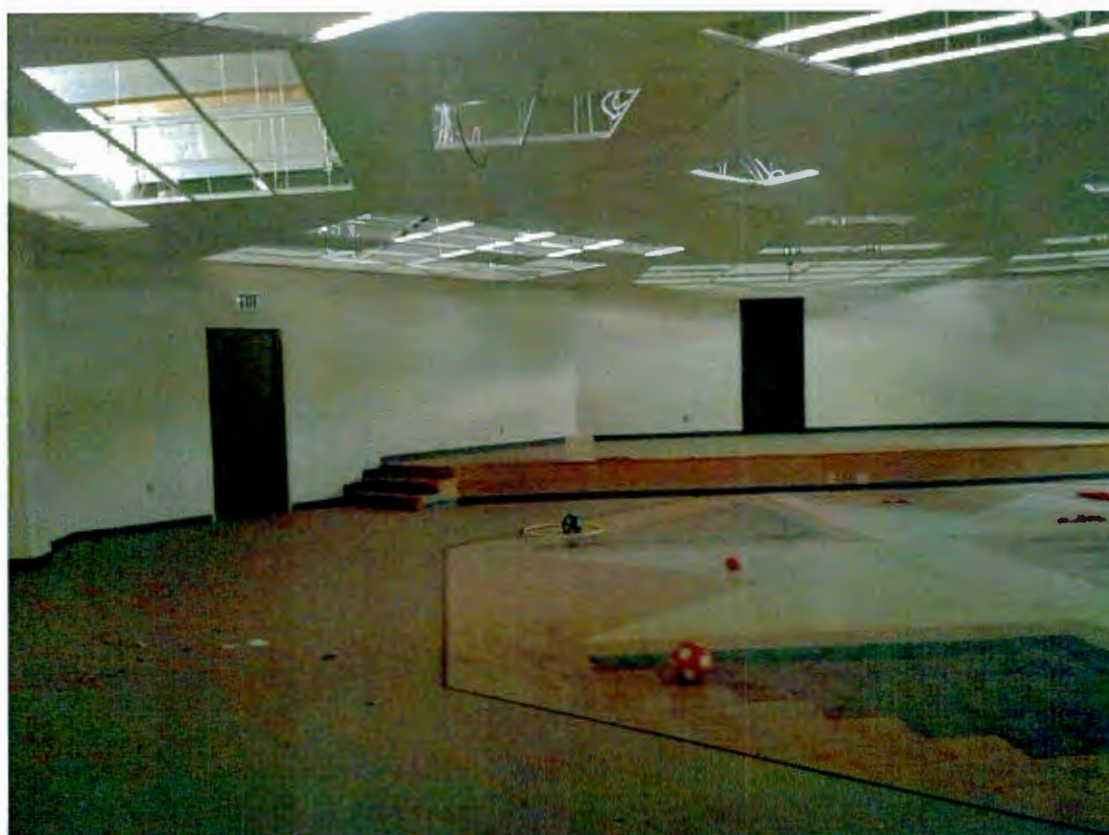
ATTACHMENT A – BUILDING 676 FORMER CULTURE ROOM AND AUDITORIUM

- e. Building 673 – CAFETERIA / KITCHEN - cafeteria which feeds approximately 428 students breakfast and lunch and 65 dinner meals for the residential students. The cafeteria also houses the food services director's office and the administrative assistant.
- f. Building 674 – GIRLS DORM – houses approximately 40 female students, office for residential assistants, activity room, tutoring room, washer and dryer room and computer lab. This building also provides space for the K-8 music program.
- g. Building 676 – VACANT BUILDING - used primarily for excess equipment and obsolete furniture. The building is not approved for student occupancy. This building once housed the Diné Language and Cultural Center which contained a simulated Hogan for cultural teachings. In addition to the culture center the building once housed the student auditorium.

Attachment A – photos of former culture center and auditorium building 676

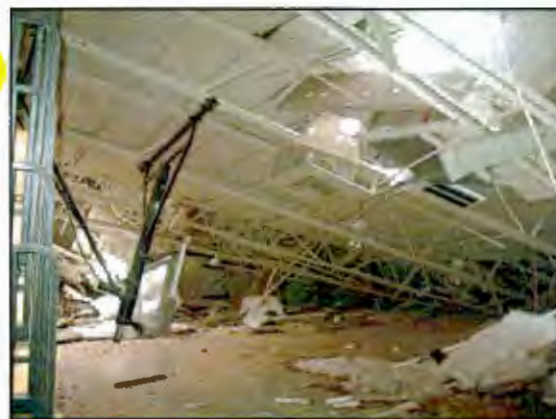
In January 2010 Shonto Preparatory School had to close due to the collapse of the school roof in the gym. The school closed for 10 school days. There is great potential the next catastrophic failure is inevitable and will result in future school closure.

The gym roof collapsed in January at Shonto Preparatory School in Arizona. The gym was built in 1966.

SHONTO, AZ – As of Tuesday, January 26, 2010, the Shonto Preparatory School Kindergarten through Eighth Grade building is still closed while the gym ceiling that has collapsed is undergoing assessment and repairs. Due to an announcement and call for snow shoveling laborers on Monday, the work to repair the school gymnasium has begun.

The same gym roof design is used at nearby Tonalea Day School, Kaibeto Boarding School and Rocky Ridge Boarding School. Elsewhere in Arizona, the Fort Apache Agency had structural damage to buildings at its McNary location due to the same storm.

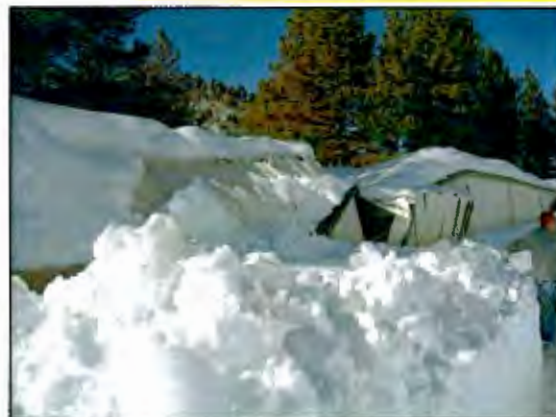
This building at the McNary location of the Fort Apache Agency in Arizona collapsed in January.

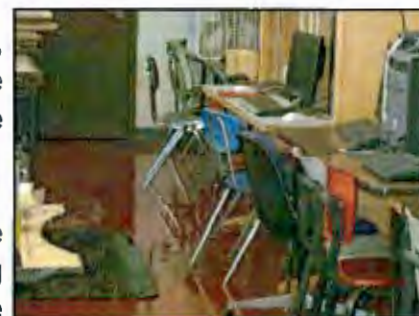
In South Dakota, a community power outage during an extreme freeze led to the bursting of pipes throughout the Cheyenne-Eagle Butte School. Also, modular buildings at Takini School had water damage and the Tiospaye Topa School water tower was damaged.

A computer lab floor glistens with water in January (above) at Cheyenne-Eagle Butte School in South Dakota, where a dorm had water damage (below), too.
