RESOLUTION OF THE  
RESOURCES AND DEVELOPMENT COMMITTEE  
24<sup>th</sup> Navajo Nation Council --- First Year, 2019

RELATING TO RESOURCES AND DEVELOPMENT COMMITTEE; APPROVING A  
TEMPORARY CONSTRUCTION EASEMENT FOR THE TERM OF ONE YEAR TO THE  
NAVAJO NATION WATER RESOURCES DEPARTMENT FOR THE PURPOSE OF  
REPLACING THE YELLOWMAN SIPHON LOCATED WITHIN THE NENAHNEZAD  
CHAPTER VICINITY (SAN JUAN COUNTY, NEW MEXICO)

- A. **Project.** This scope of work covers all material not furnished by the Owner and workmanship required to replace 2,450 ft of Yellowman Siphon, replace the inlet structure, replace two road

- B. **General.** The Yellowman Siphon is a 36-inch above-ground steel pipe siphon that is part of Fruitland Canal. Most of the steel siphon has been previously replaced by others. Only 2,450 ft remain to be replaced. The siphon is located on the south side of the San Juan River, approximately one mile southwest of the town of Fruitland, New Mexico. The siphon is located in Nenahnezad Chapter, Navajo Nation.

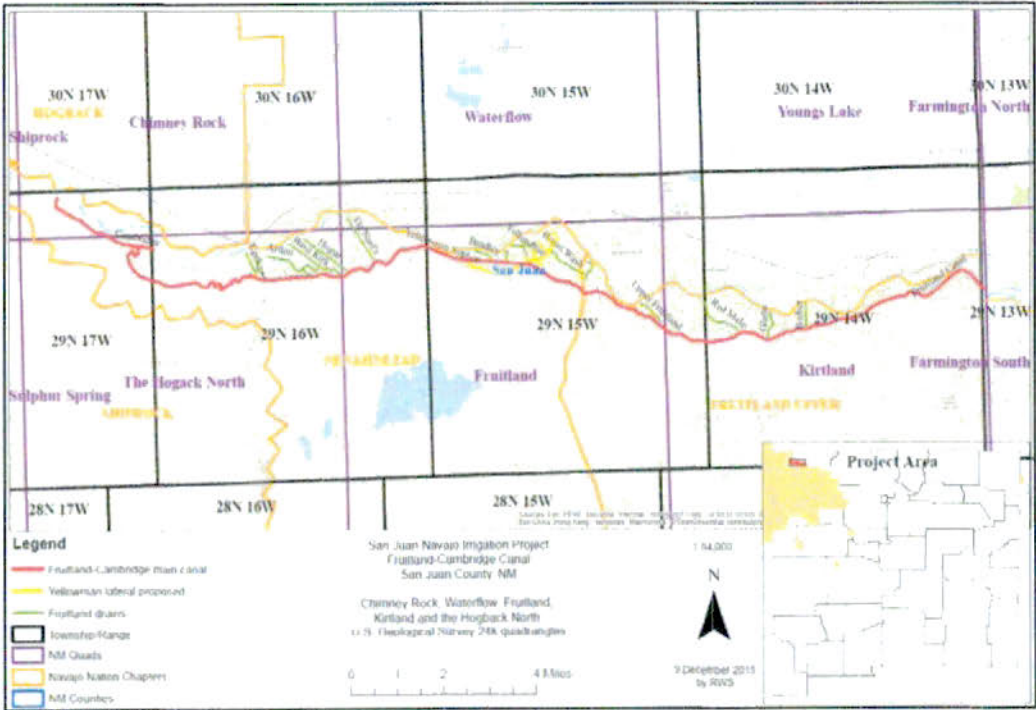
Figure 2. Vicinity map for Fruitland-Cambridge irrigation unit.

Water depletions from the San Juan River by the Fruitland-Cambridge irrigation unit are 7,898 acre-feet/year (AFY) and 13,000 AFY for Hogback-Cudei (Service 2009). The Fruitland-Cambridge canal has a maximum diversion capacity of 160 cfs with a limit of 100 cfs into the portion of the canal below the second sluiceway (also identified as the fish return or flow return channel). Both the Fruitland-Cambridge and Hogback-Cudei diversions are considered historical depletions (those in existence prior to 1992) and part of the historical baseline for section 7 consultation purposes (Service 2000). Formal consultation of Hogback-Cudei water depletions was conducted in 2011 (Service 2011) but formal consultation has been not been conducted for Fruitland-Cambridge water depletions. Approximately 50% of water diverted by both irrigation units is returned to the river either by surface runoff or subsurface flow from deep percolation of agriculture fields or through return channels (labeled as drains in Figure 2 and Figure 3).

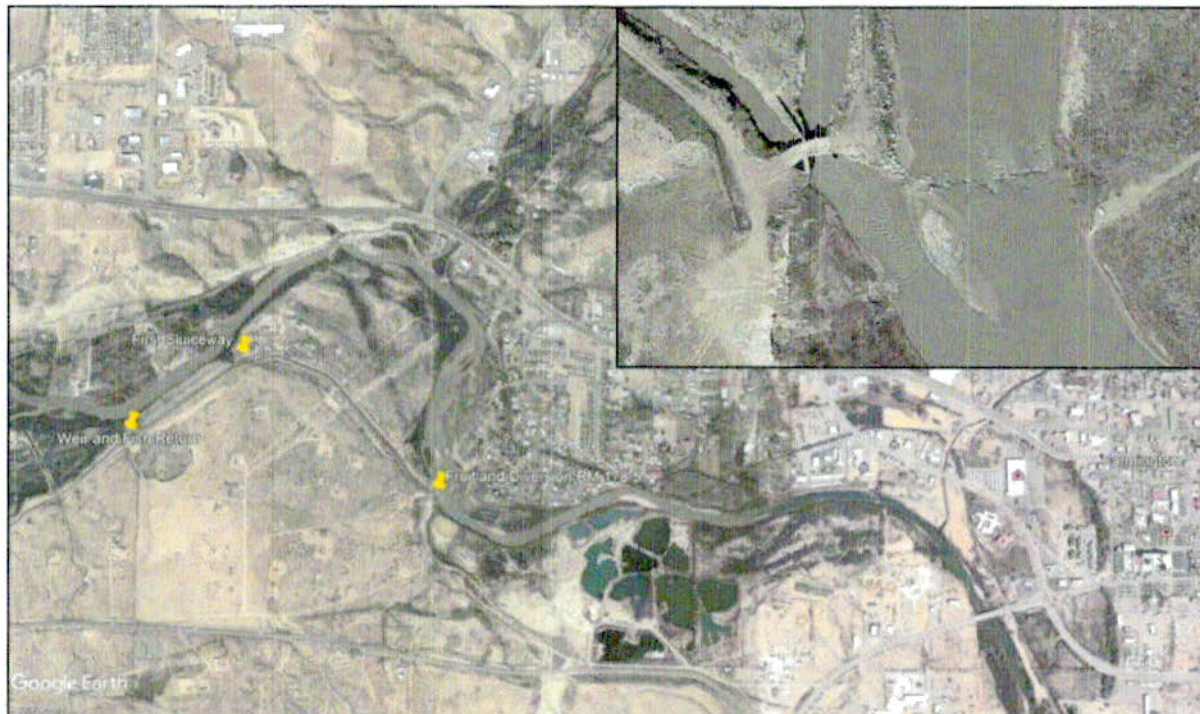
Figure 4. Location of Fruitland-Cambridge irrigation unit inlet works, first sluiceway, fish barrier weir, and fish return (flow return), San Juan River river mile (RM) 178.5 Farmington, NM. Insert of current diversion dam and inlet works.

Diversion of the San Juan River into the Fruitland-Cambridge unit is approximately 3 km (2 mi) west of Farmington, New Mexico (Figure 4) on property owned by the City of Farmington and a private landowner. The remaining Fruitland-Cambridge infrastructure is located in San Juan, Nenahnezad and Upper Fruitland Chapters, Navajo Nation, San Juan County, New Mexico. These are in Chimney Rock, Waterflow, Fruitland, Kirtland and Hogback North U.S. Geological Survey 24k quadrangles (Figure 2). The Hogback-Cudei irrigation unit is located in the Gadii'ahi, Beclabito, Shiprock, and Hogback Chapters, Navajo Nation, San Juan County, New Mexico. These are in Sallies Spring, Canal Creek, Skinney Rock, Rattlesnake, Shiprock, Chimney Rock, and Hogback North U.S. Geological Survey 24k quadrangles (Figure 3).

Additional construction may occur in the fish return channel (flow return to river). This channel may be regraded to remove any existing brush or rock checks that formed and would be detrimental to fish passage. If necessary, the channel will be armored in locations where erosion is occurring (NNDWR 2017b). The channel slope and cross-section will be designed to provide at least 0.3 m (1 ft) of depth at the minimum design flow of 25 cfs (NNDWR 2017b). There are no plans to modify the first sluiceway (Figure 4) or its headgates (NNDWR 2017b).

The first place in the main canal where fish may be adversely affected is the first sluiceway (Figure 4). This sluiceway has a steep drop, when sluicing operations are underway. Injury or mortality to fish could occur from the steep drop or if the sluiceway is drained in such a manner that fish become stranded. Under the proposed action, the need to use this sluiceway will be reduced to times when sediment must be removed from the upper reach of the canal. It is anticipated that the gate to this sluiceway will be opened in the fall at the end of the irrigation season to drain the canal and flush accumulated sediment to the river. It may be necessary to perform up to two additional sluicing operations for sediment removal during the season. The duration of each sluicing operation is expected to be eight hours or less.

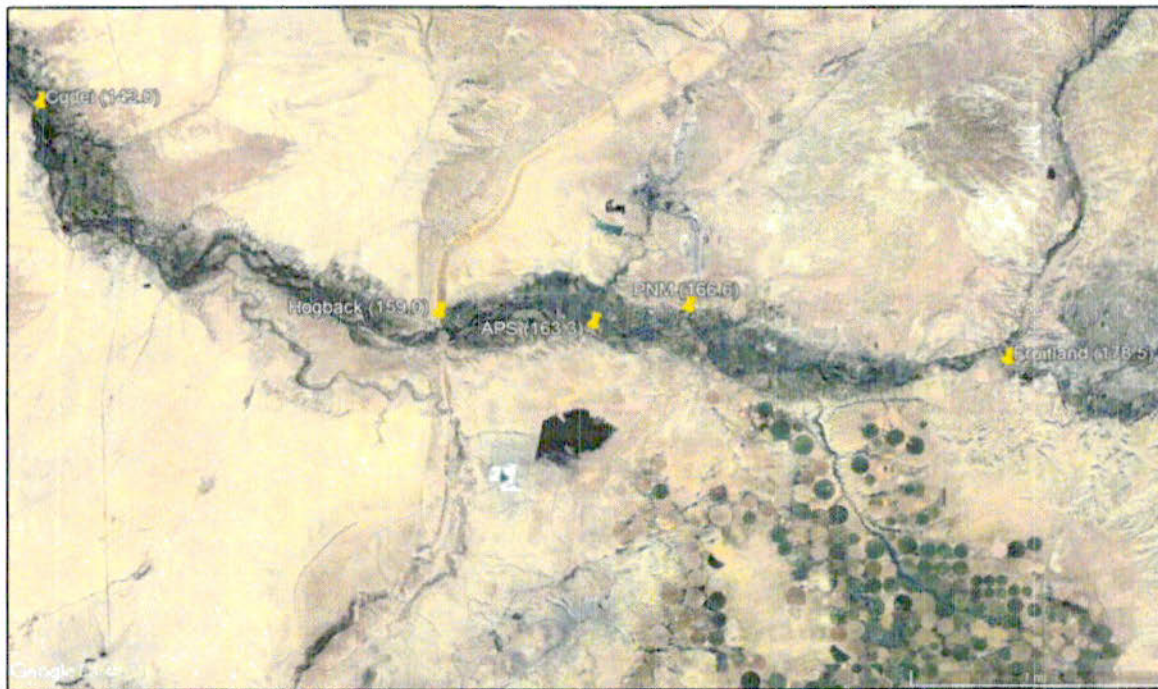
Figure 16. San Juan River diversion structures - river mile location denoted in parenthesis.

In 1997, five San Juan River instream water diversion structures (weirs) were identified as possible impediments to fish passage. These diversion structures, Cudei, Hogback, San Juan Generating Station [PNM], Arizona Power Station [APS], and Fruitland-Cambridge, are within 60 river km (36.5 river miles) of one another, west of Farmington, NM (Figure 4 and Figure 16) and within critical habitat. Movement analyses indicated native fish could move upstream or downstream over all five weirs at certain river flows (Buntjer and Brooks 1997, Ryden 2000a).

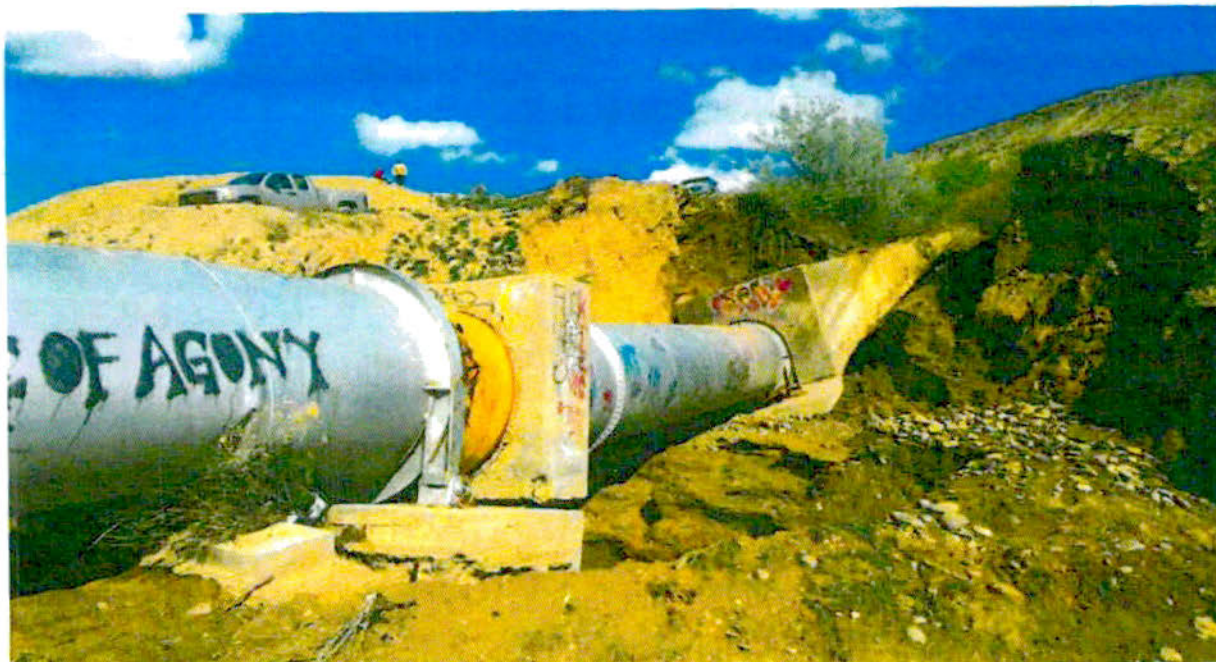
**Figure 4. Recent failure of Salt Creek Siphon.**
